Inspection Report

H3 Inspection and Services

Property Address

1234 Happy Ave
Huntsville AL 35763

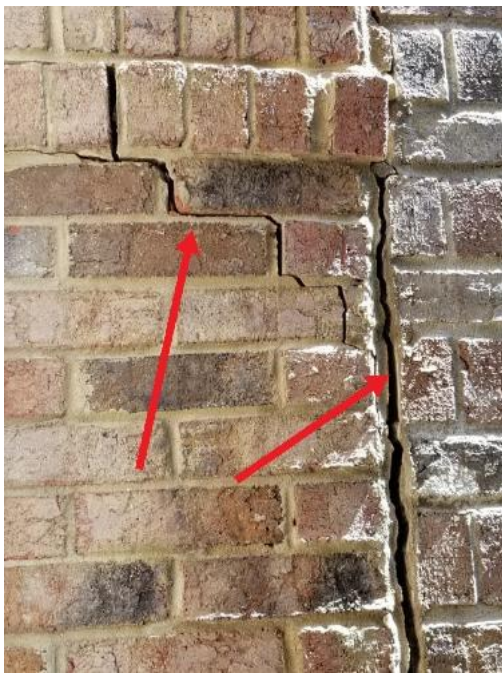
Minor slab settlement was observed. Some repair may be warranted. The front porch steps foundation has settled. You can see railing has slightly come loose from house and slight separation of stairs from house foundation. It is suggested that a "Licensed General Contractor" be contacted for further evaluation and repair.

Brick step foundation has settled

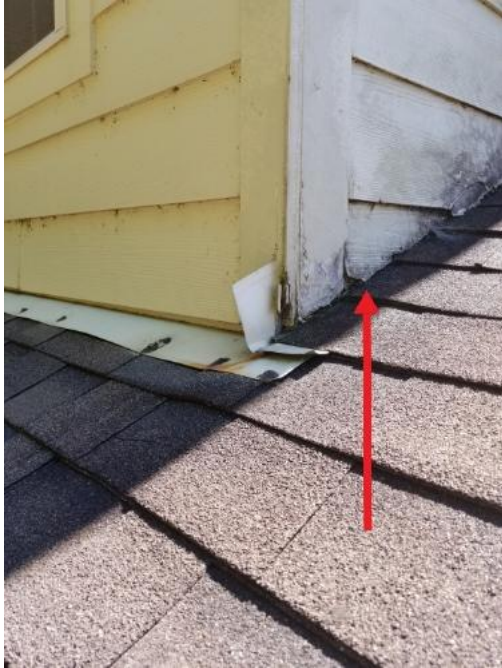
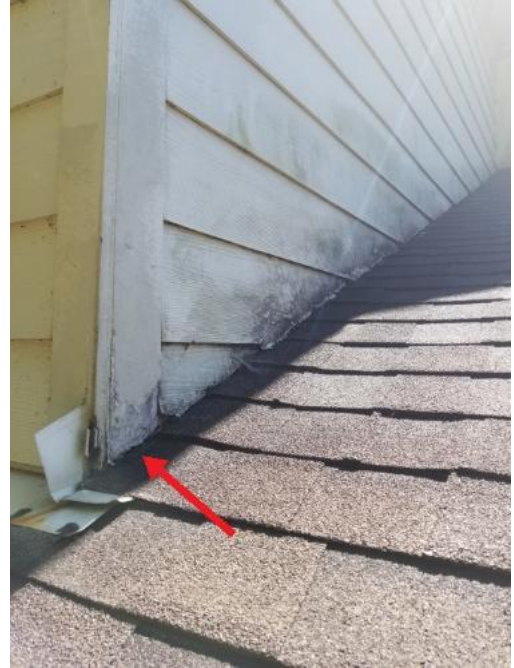
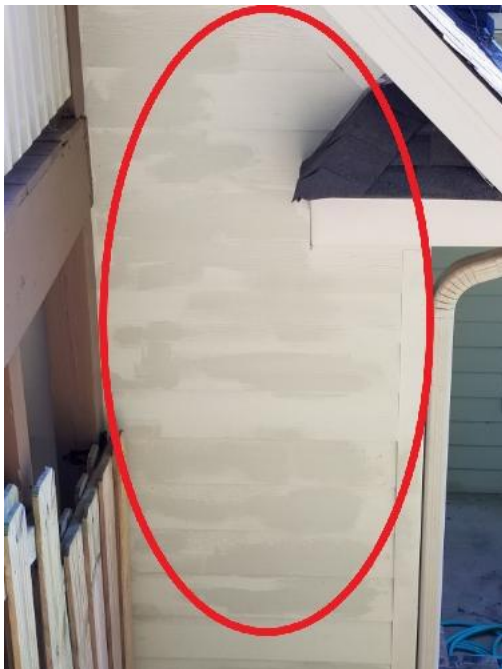
Moisture damage and possible evidence of water penetration were observed above back covered porch wall. Due to conditions observed, hidden damage may exist in areas not visible or readily accessible.

Some discoloration on siding

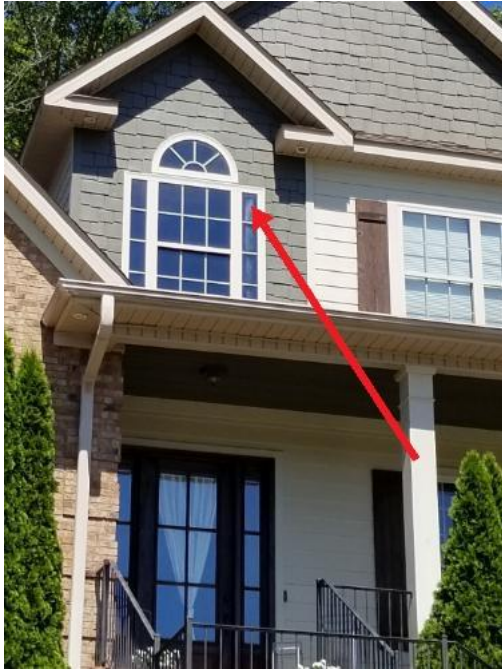
The thermal pane window(s) at appear to have lost its / their thermal seal. Moisture, fogging, and hazing are common signs of this condition. While mostly cosmetic, this condition is generally not repairable. Correction would require replacement of the window(s) or window pane(s).

Thermal seal broken

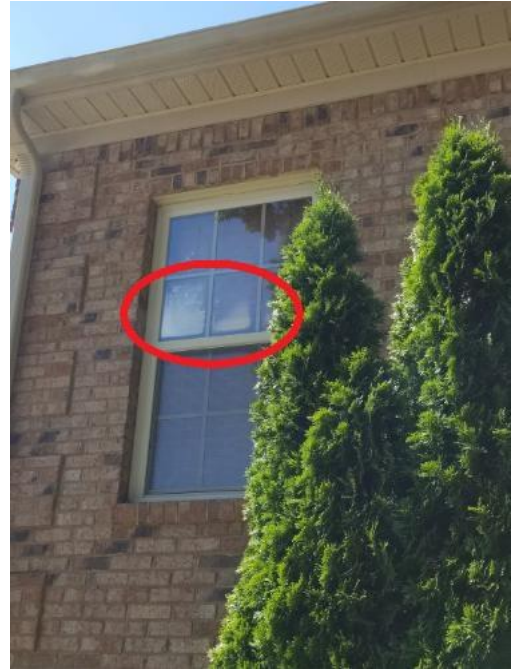
Thermal seal broken

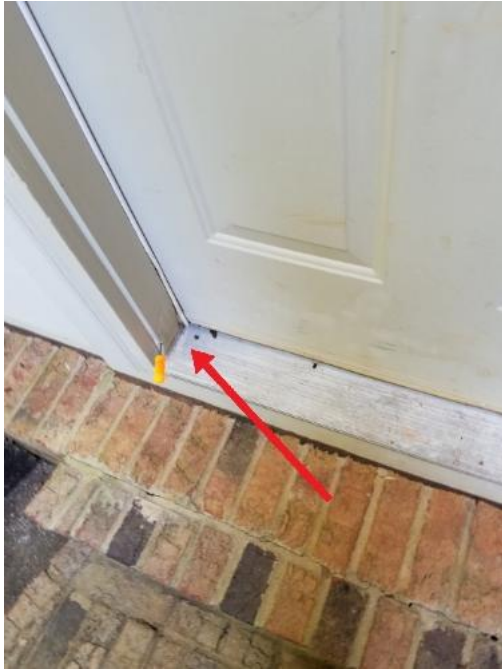
1. "Man door" to garage has small area of rotted wood at bottom of the frame(casing) the "man" door was also difficult to operate deadbolt.
2. Back door to sun room trim has damage toward the bottom of the trim
3. Back door from sun room into house has damage to trim. Pet related scratching / damage was observed at door(s).

1. Rotted trim

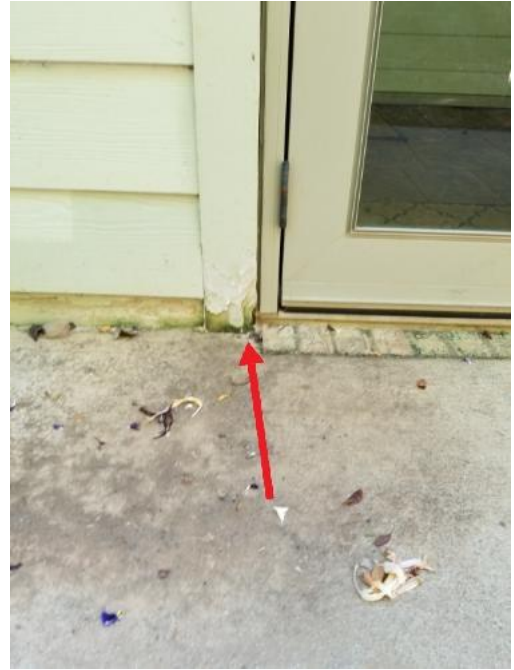
2. Trim damage

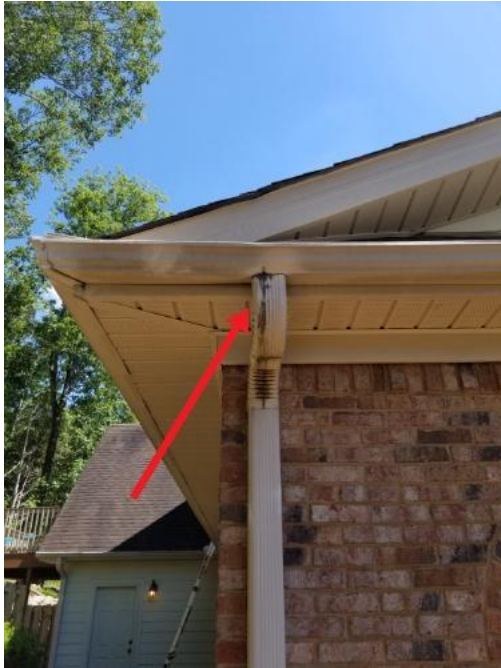
The gutters at the rear corner of the sun porch were filled with leaves and debris at the time of the inspection. Suggest cleaning and removal of debris on a regular basis. This condition can cause water penetration at the eave area. Recommend gutter downspouts be extended and routed away from the building for proper drainage. Water seepage into crawl spaces, basements and under foundations can be caused by inadequate removal of rainwater from the perimeter of the house.

Clogged and evidence of past leaks

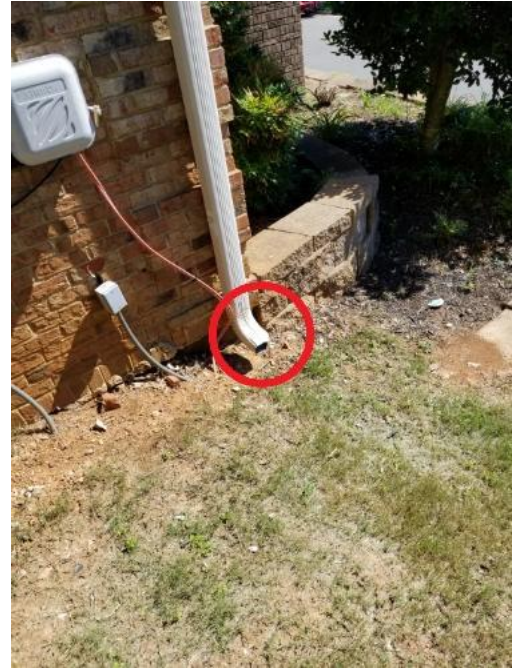
Extend 4-6 feet away from house

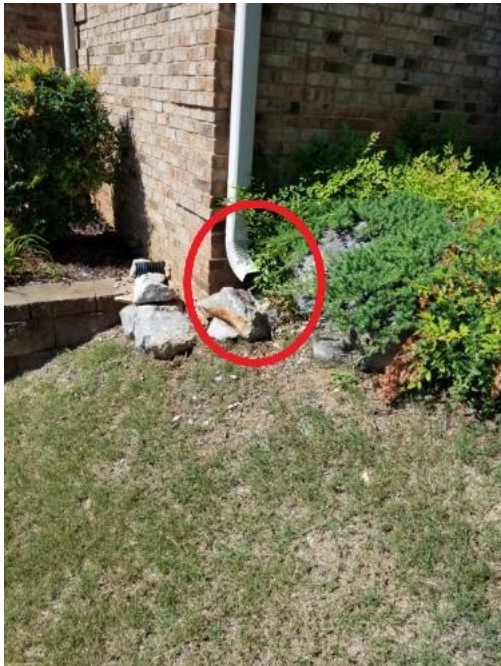
Extend 4-6 feet away from house

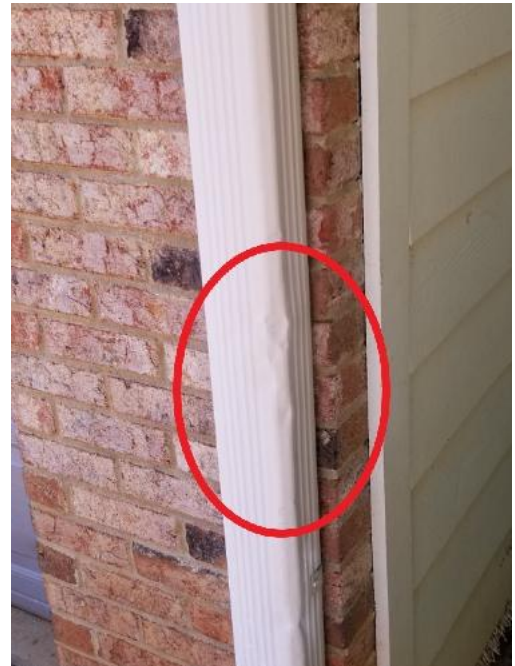
Slight damage to gutter near garage door

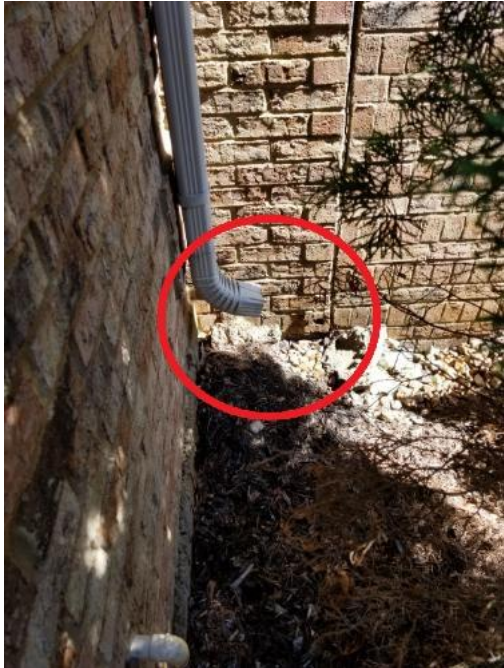
Extend gutter 4-6 feet away from house

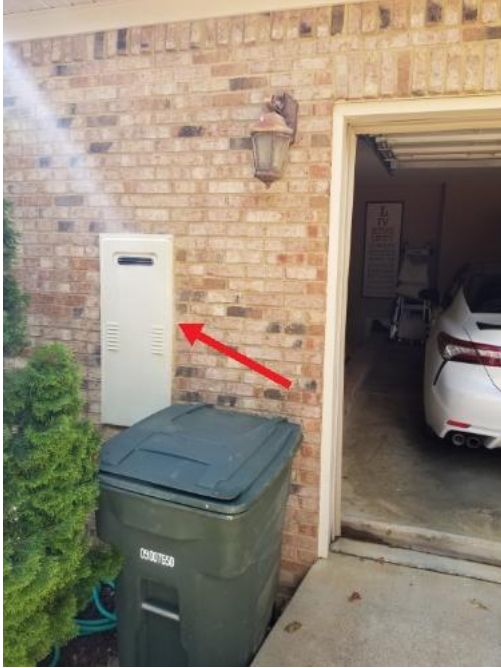
Tankless hot water heater

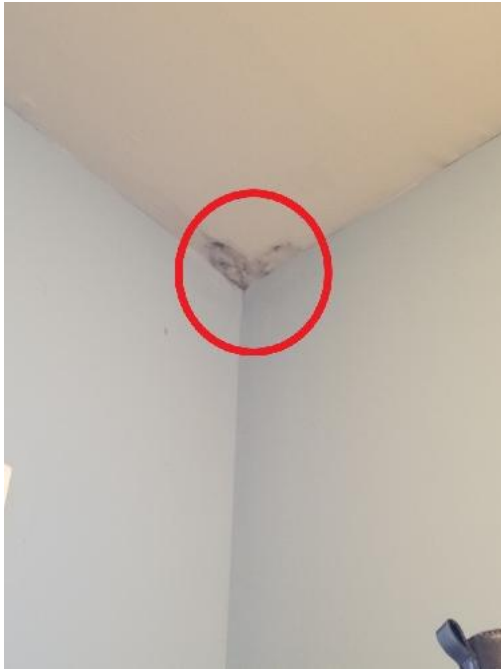
There were stains at primary bedroom closet. The stain was dry at time of inspection. The inspector was unable to determine if the leak was active at the time of the inspection. Further evaluation by a qualified contractor is recommended. Please refer to limitations of inspection regarding mold / moisture related conditions.

Primary closet

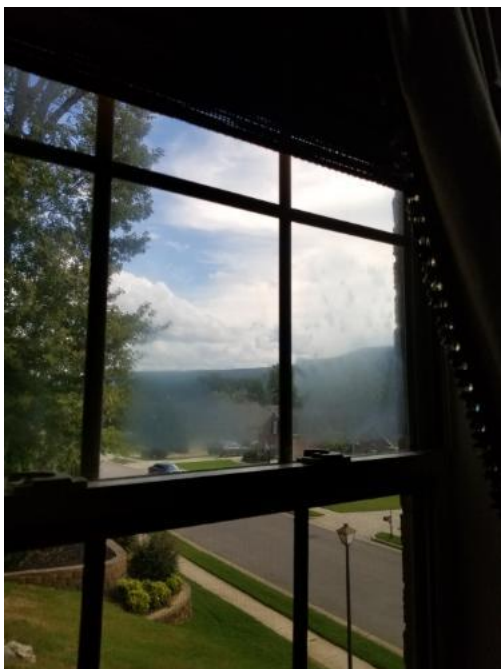
The thermal pane window(s) at front side of house appear to have lost its / their thermal seal. Moisture, fogging, and hazing are common signs of this condition. While mostly cosmetic, this condition is generally not repairable. Correction would require replacement of the window(s) or window pane(s).

Cloudy window. Top sash has broken thermal pain

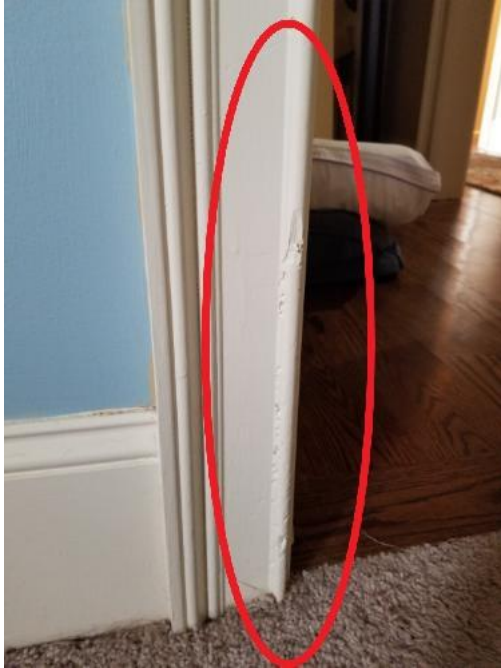
Pet related scratching / damage was observed at doors.

Apparent scratching

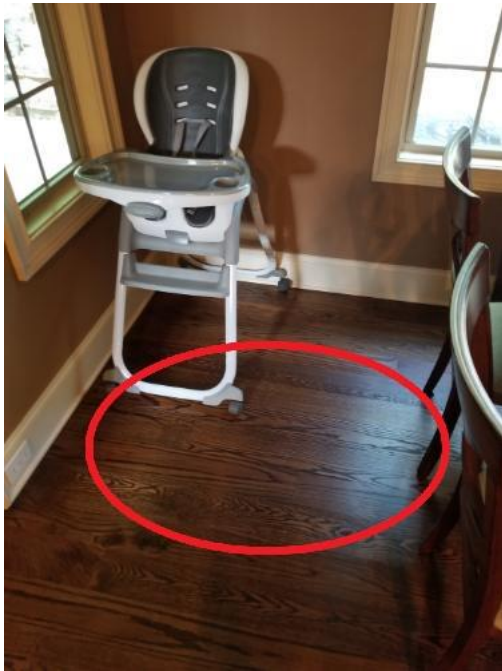
The general condition of the visible and accessible portions of the floors appeared to be in serviceable condition at the time of the inspection. There was one section of hardwood in the breakfast area that is slightly warped

Slight warping in the floor

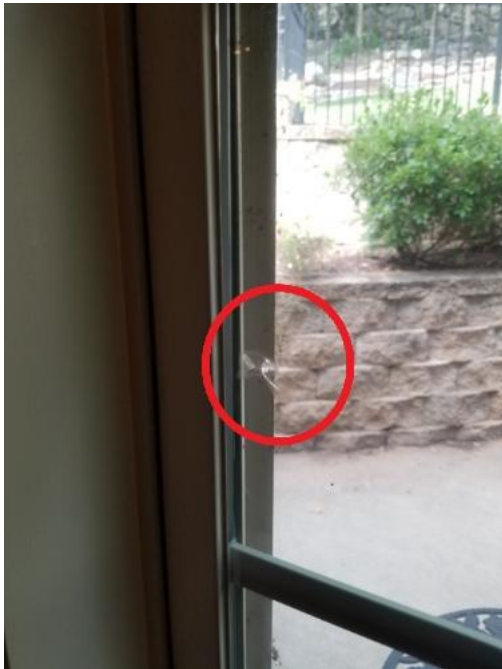
Cracked glass pane(s) were observed at breakfast room top left window. There is a small chip in the window. Recommend repair as needed.

Chip in window.

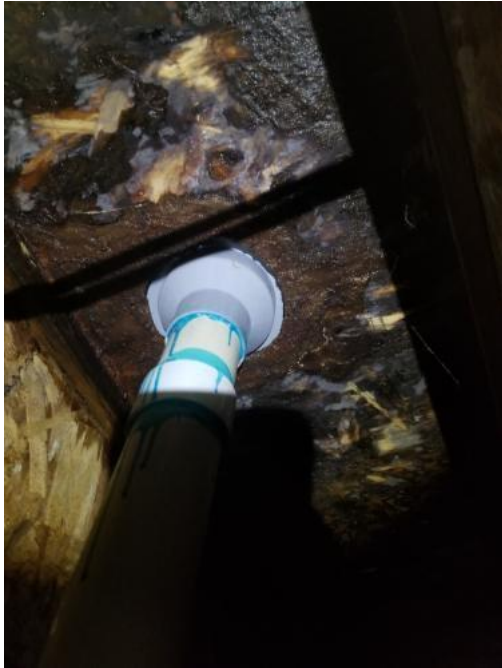
the steam shower does not produce steam. Steam generator does not appear to work. In addition the steam shower has a leak as evident when inspecting the subfloor in the crawlspace.

Subfloor below steam shower is leaking

The steam shower in the master bathroom appears to have a leak. The subfloor is wet. It is suggested that a "Licensed Plumbing Contractor" be contacted for further evaluation and repair.

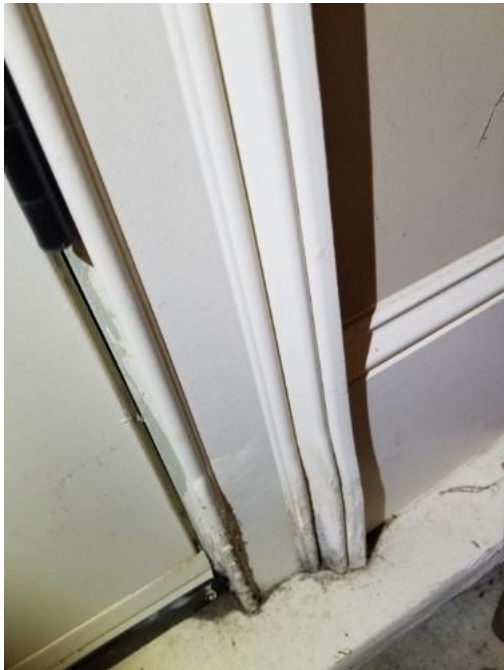
Moisture related damage was observed. Recommend further evaluation and repair as needed by a qualified / licensed contractor.

Man door casing shows some signs of water damage
